INVESTIGATION INTO THE MECHANISM OF DEGRADATION OF SOLAR CELLS WITH SILVER-TITANIUM CONTACTS

D2-126194-1

FIRST QUARTERLY PERIODIC PROGRESS REPORT

THE BOEING COMPANY, AEROSPACE GROUP, KENT FACILITY
SEATTLE, WASHINGTON

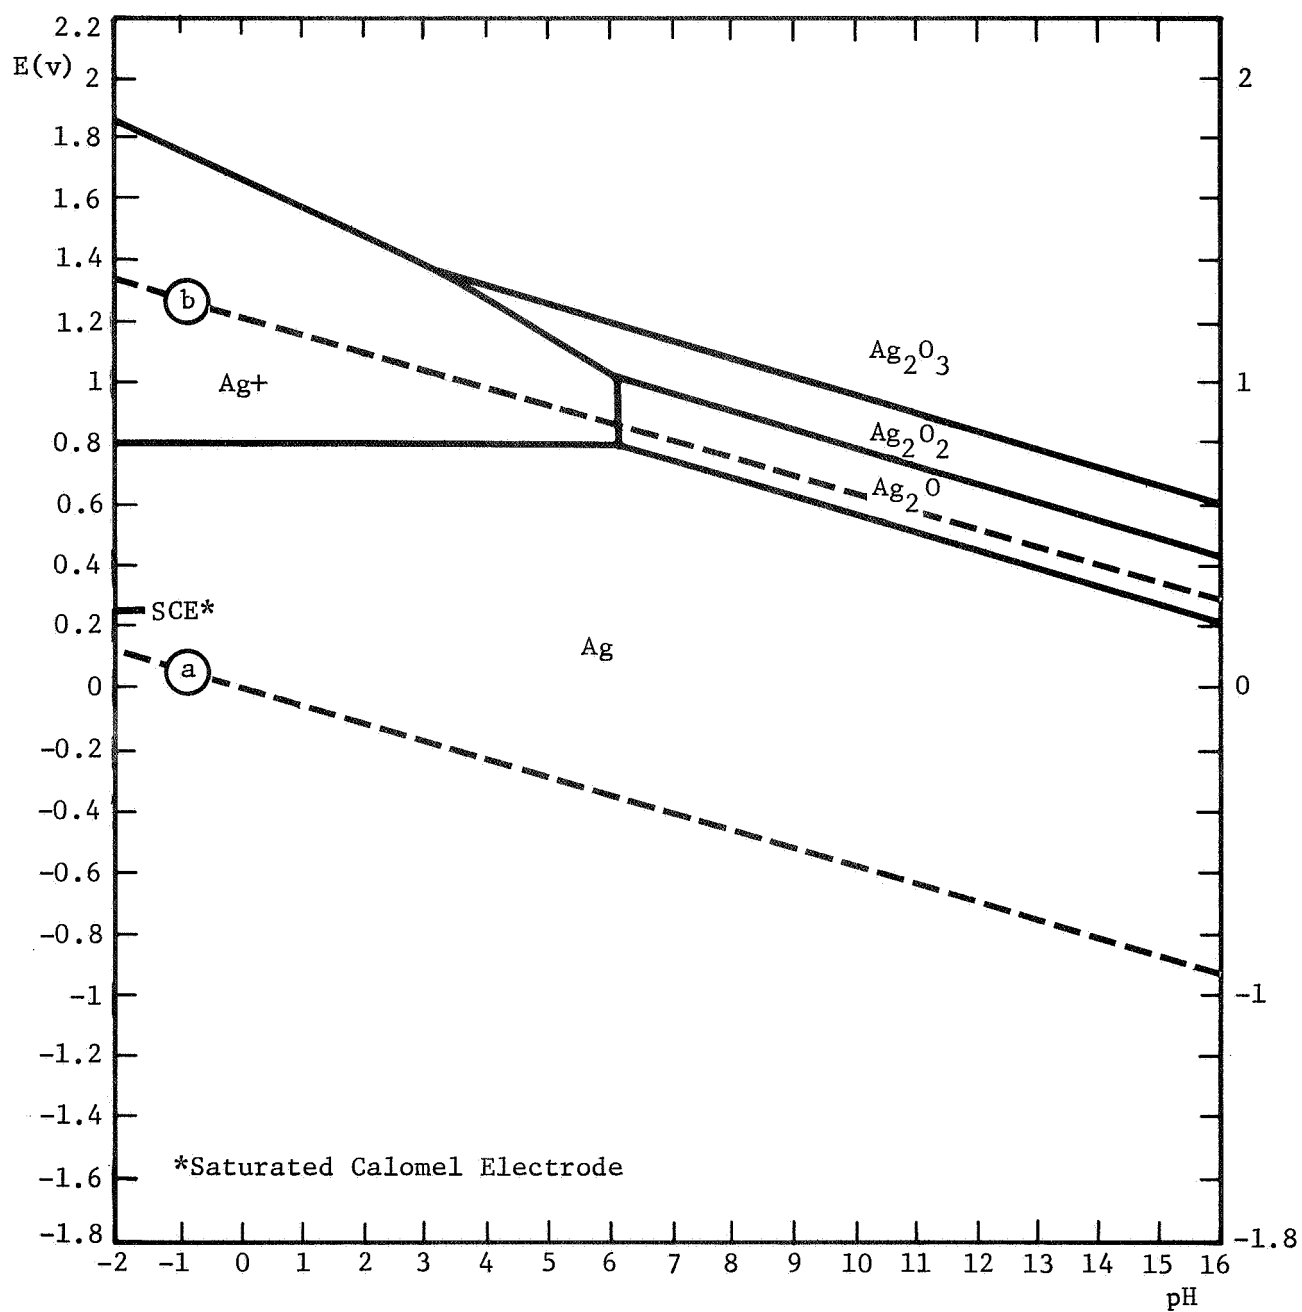
Figure 1: pH VERSUS POTENTIAL FOR SILVER-WATER SYSTEM AT 25° C

Contaminating ions can accelerate the process by breaking the oxide coating on the titanium or by chemically entering the reaction (e.g., Ti forms a stable complex with F^- at low pH values). We hope to determine the reaction mechanism by testing cells in various chemical solutions at different pH values. Various chemical species are thermodynamically stable depending on the pH of the solution. Figures 1 and 2 (Ref. 7) show the potential -pH diagrams for the silver-water and titanium-water systems at 25°C, and indicate regions where various species exhibit stable characteristics. Lines a and b refer to the boundaries for H_2 and O_2 reduction. Above a, the reaction $2\text{H}^+ + 2\text{e}^- \rightarrow \text{H}_2$ is thermodynamically impossible. Above b, the reaction $4\text{H}^+ + \text{O}_2 + 4\text{e}^- \rightarrow 2\text{H}_2\text{O}$ is impossible. For the titanium-water system the region of interest is bounded approximately by potentials of +0.2 volts and -1.2 volts at a pH of -1, and -0.8 volts and -2.2 volts at a pH of 14.

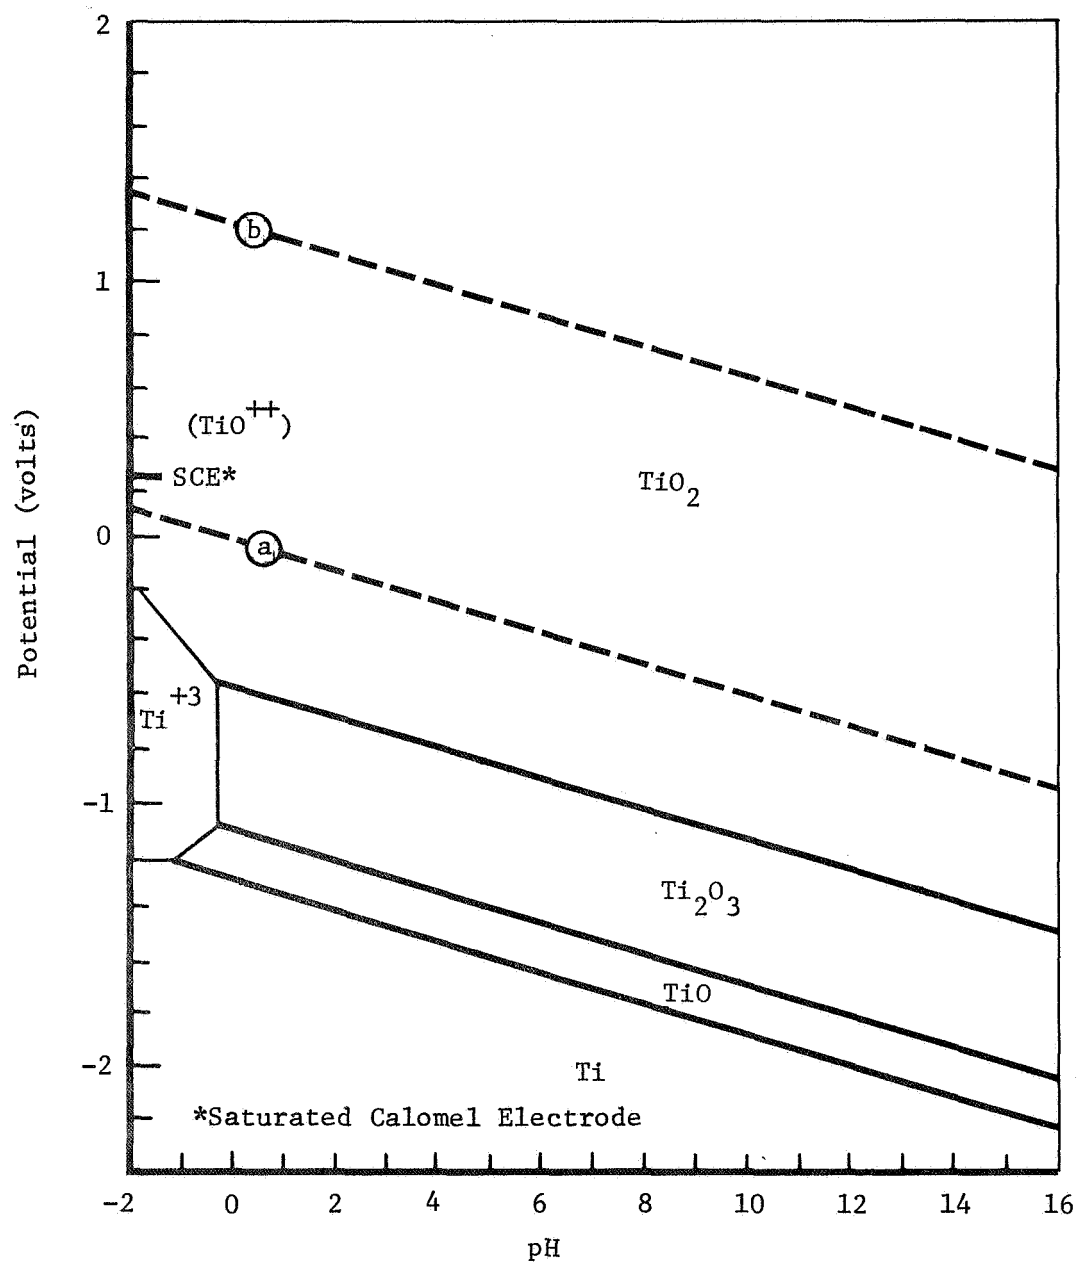
Figure 2: pH VERSUS POTENTIAL FOR TITANIUM-WATER SYSTEM AT 25⁰ C

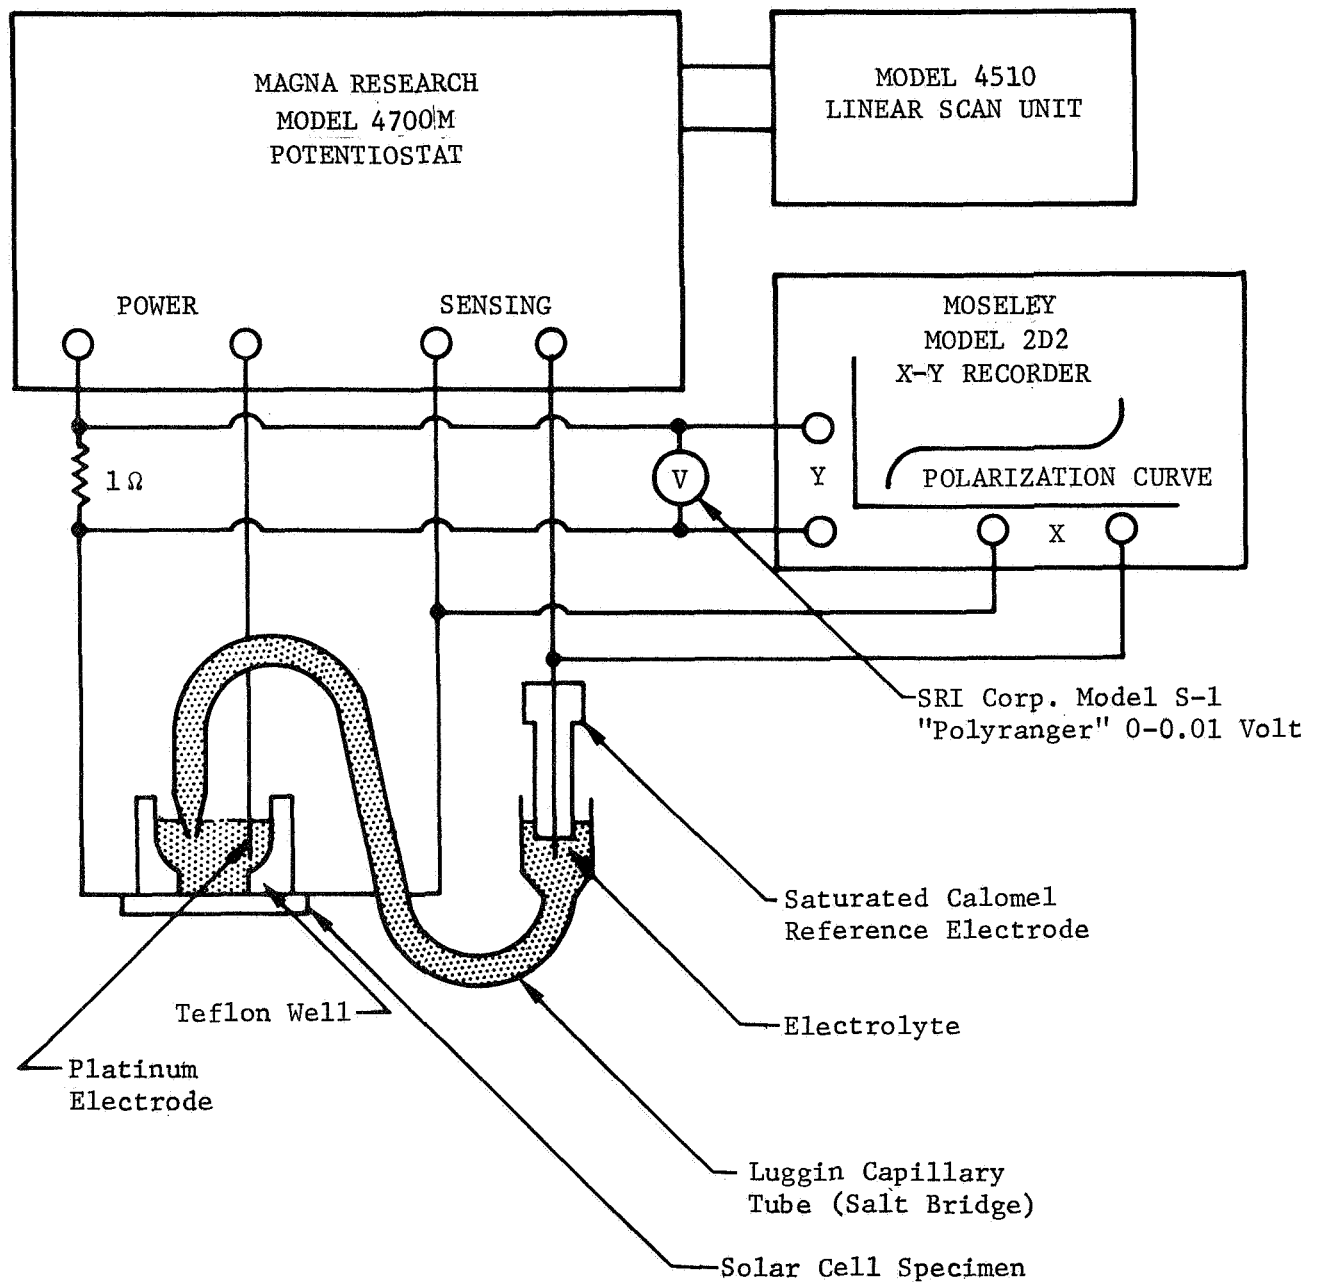
Figure 3: CONSTANT POTENTIAL APPARATUS

We had to apply potentials to the electrodes in order to study the systems as a function of potential and to learn about the reaction mechanisms in terms of polarization or overpotential of the electrodes. The solar cell, acting as the control electrode, was placed in a Teflon cell filled with the appropriate solution (Figures 3 and 4). A platinum wire served as the counter electrode and a saturated calomel reference electrode (SCE) (Figure 5) was used. A Magna Potentiostat (Model 4700M) was used to measure the current as a function of applied potential.

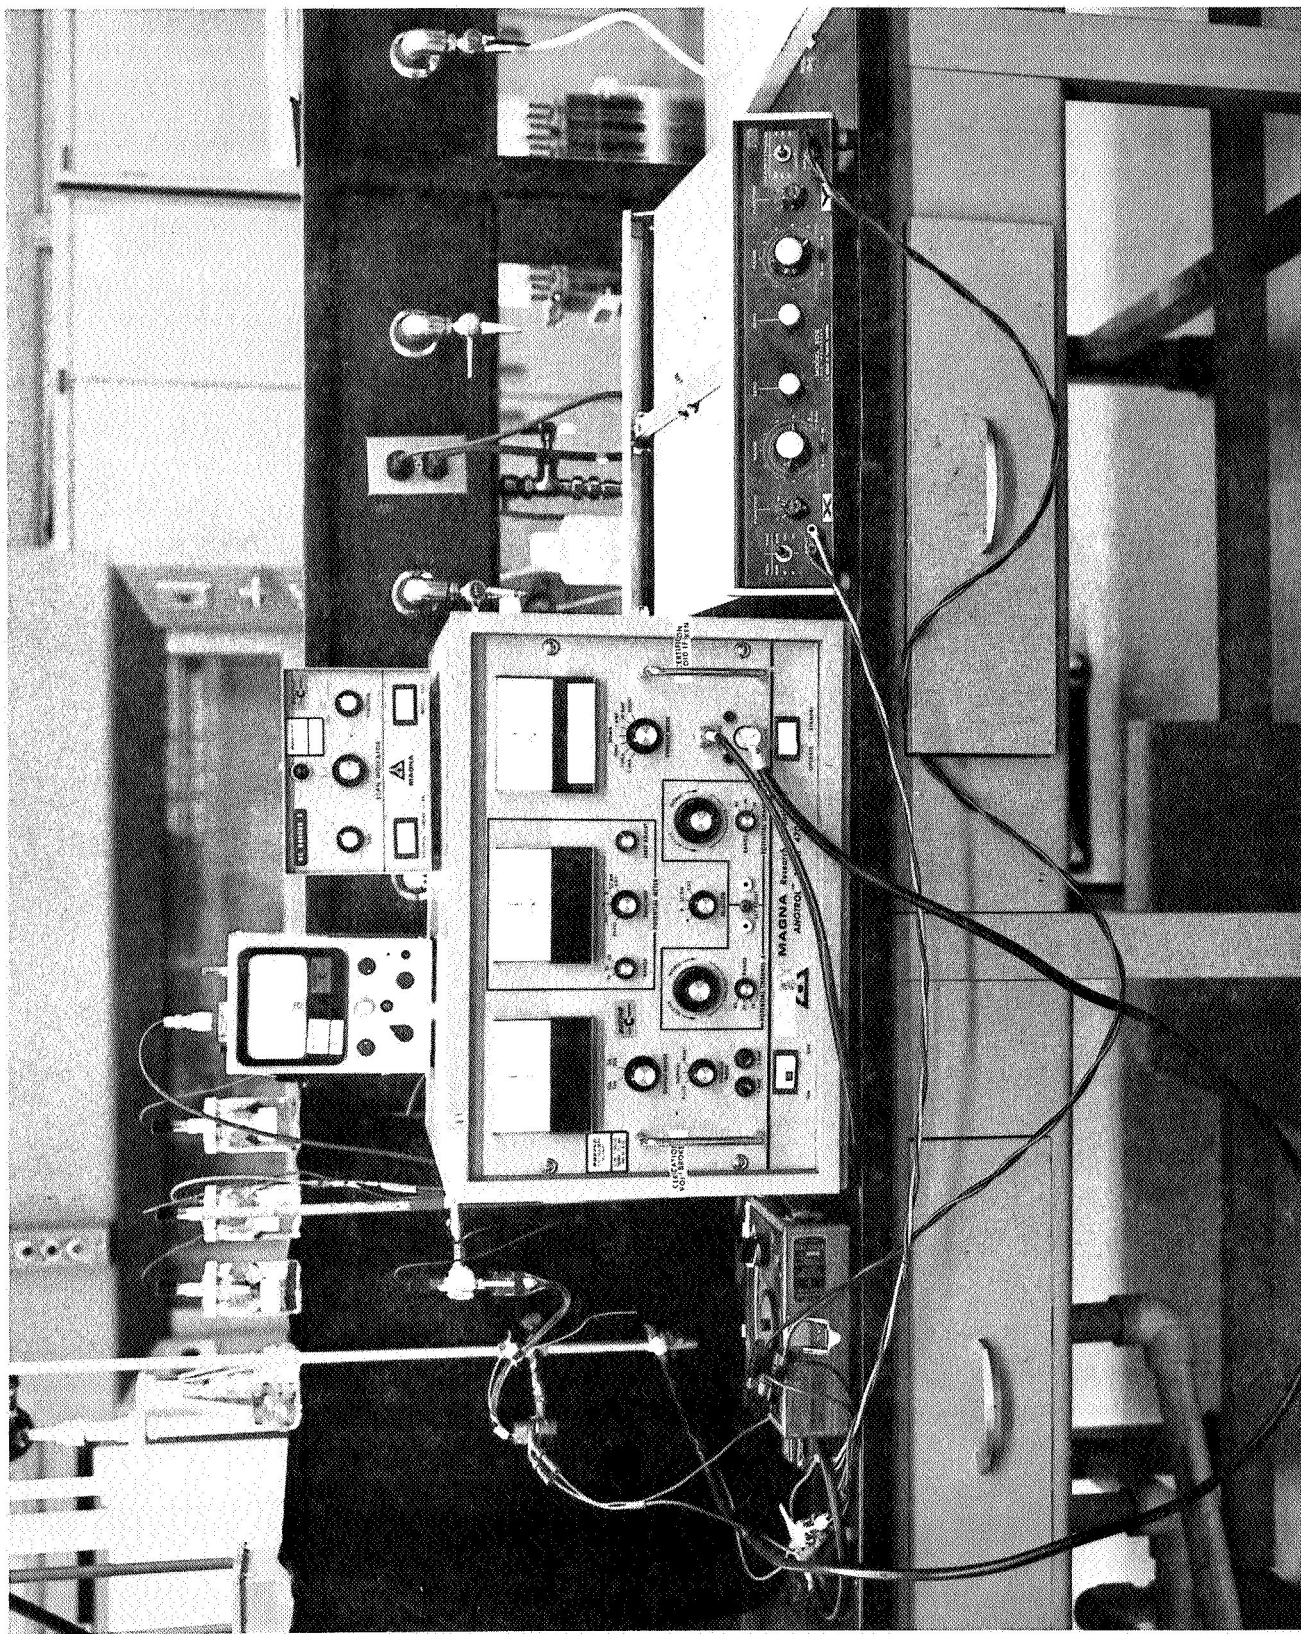
Figure 4: POTENTIOSTATIC TEST SETUP

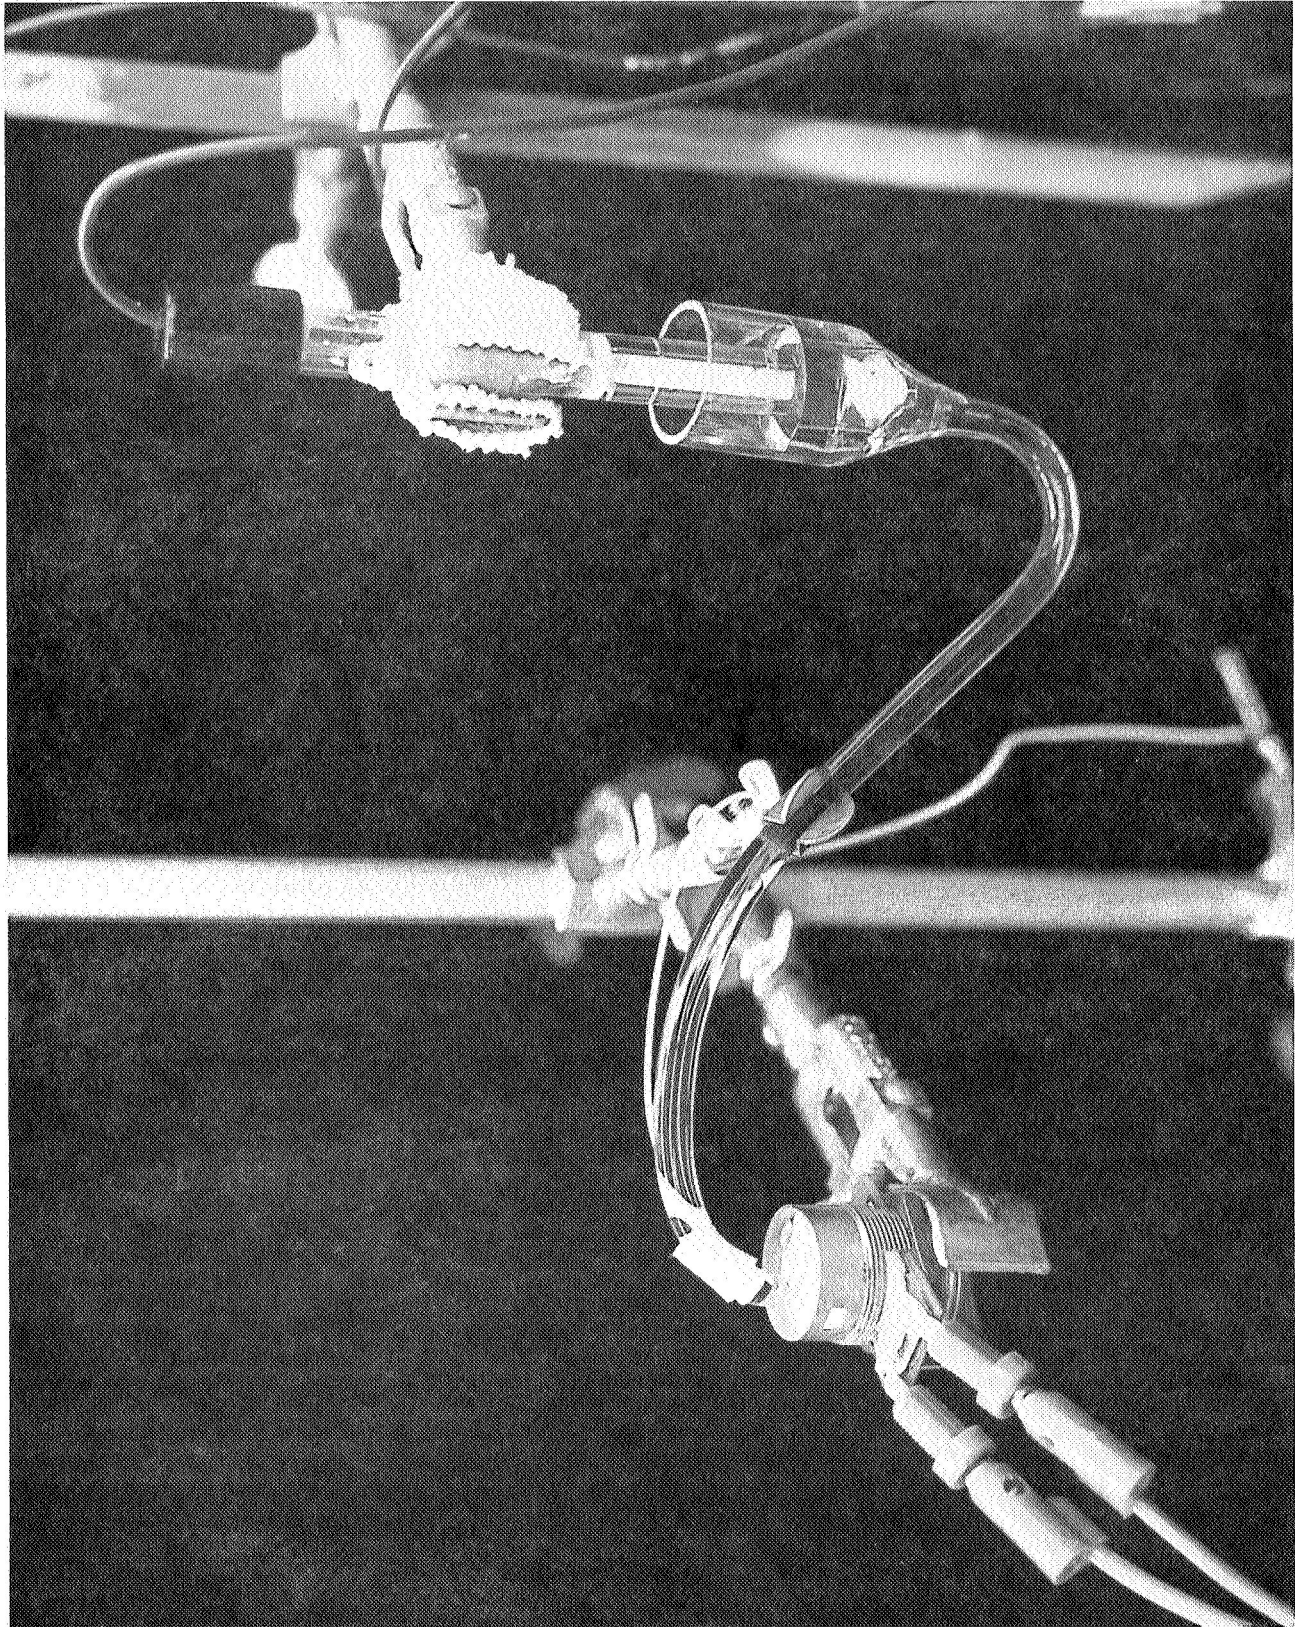
Figure 5: SPECIMEN HOLDER, LUGGIN CAPILLARY, AND REFERENCE CALOMEL ELECTRODE

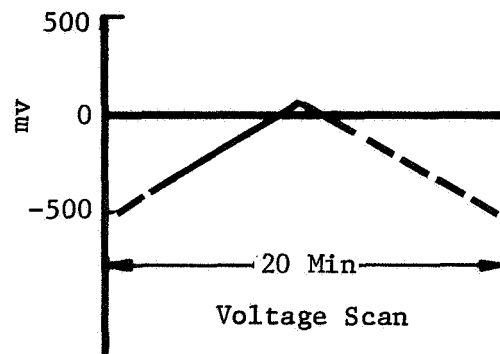
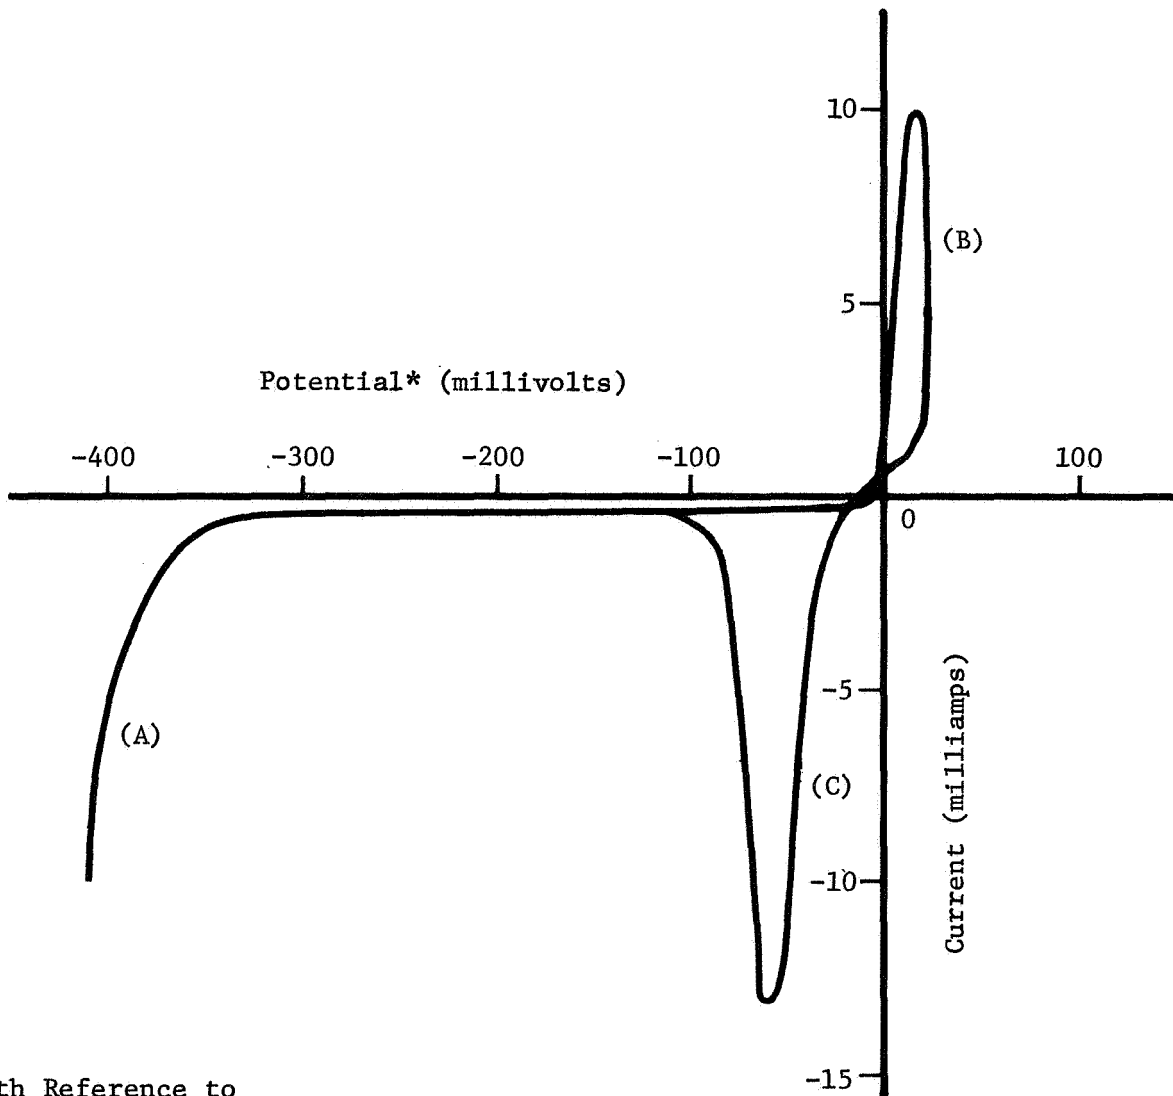
Specimen: Cell No. 115
Electrolyte: HCl
Solution: 1 Normal

*With Reference to
Saturated Calomel Electrode

Figure 6: HCl POLARIZATION CURVE

Potential varied as a sawtooth function of time applied to the cells produced the polarization curve for 1N HCl shown in Figure 6. The area labeled "A" corresponds to cathodic behavior of the cell where the reaction is $2H^+ + 2e^- \rightarrow H_2$. In area "B" the cell becomes anodic and silver oxidizes to give silver chloride by the reaction $Ag + Cl^- \rightarrow AgCl + e^-$. Region "C" corresponds to the reduction of the species oxidized in region "B" ($AgCl + e^- \rightarrow Ag + Cl^-$). The shapes of regions "B" and "C" are expected to vary as functions of the past history of the cell. The polarization curves indicate the irreversibility of an electrode process.

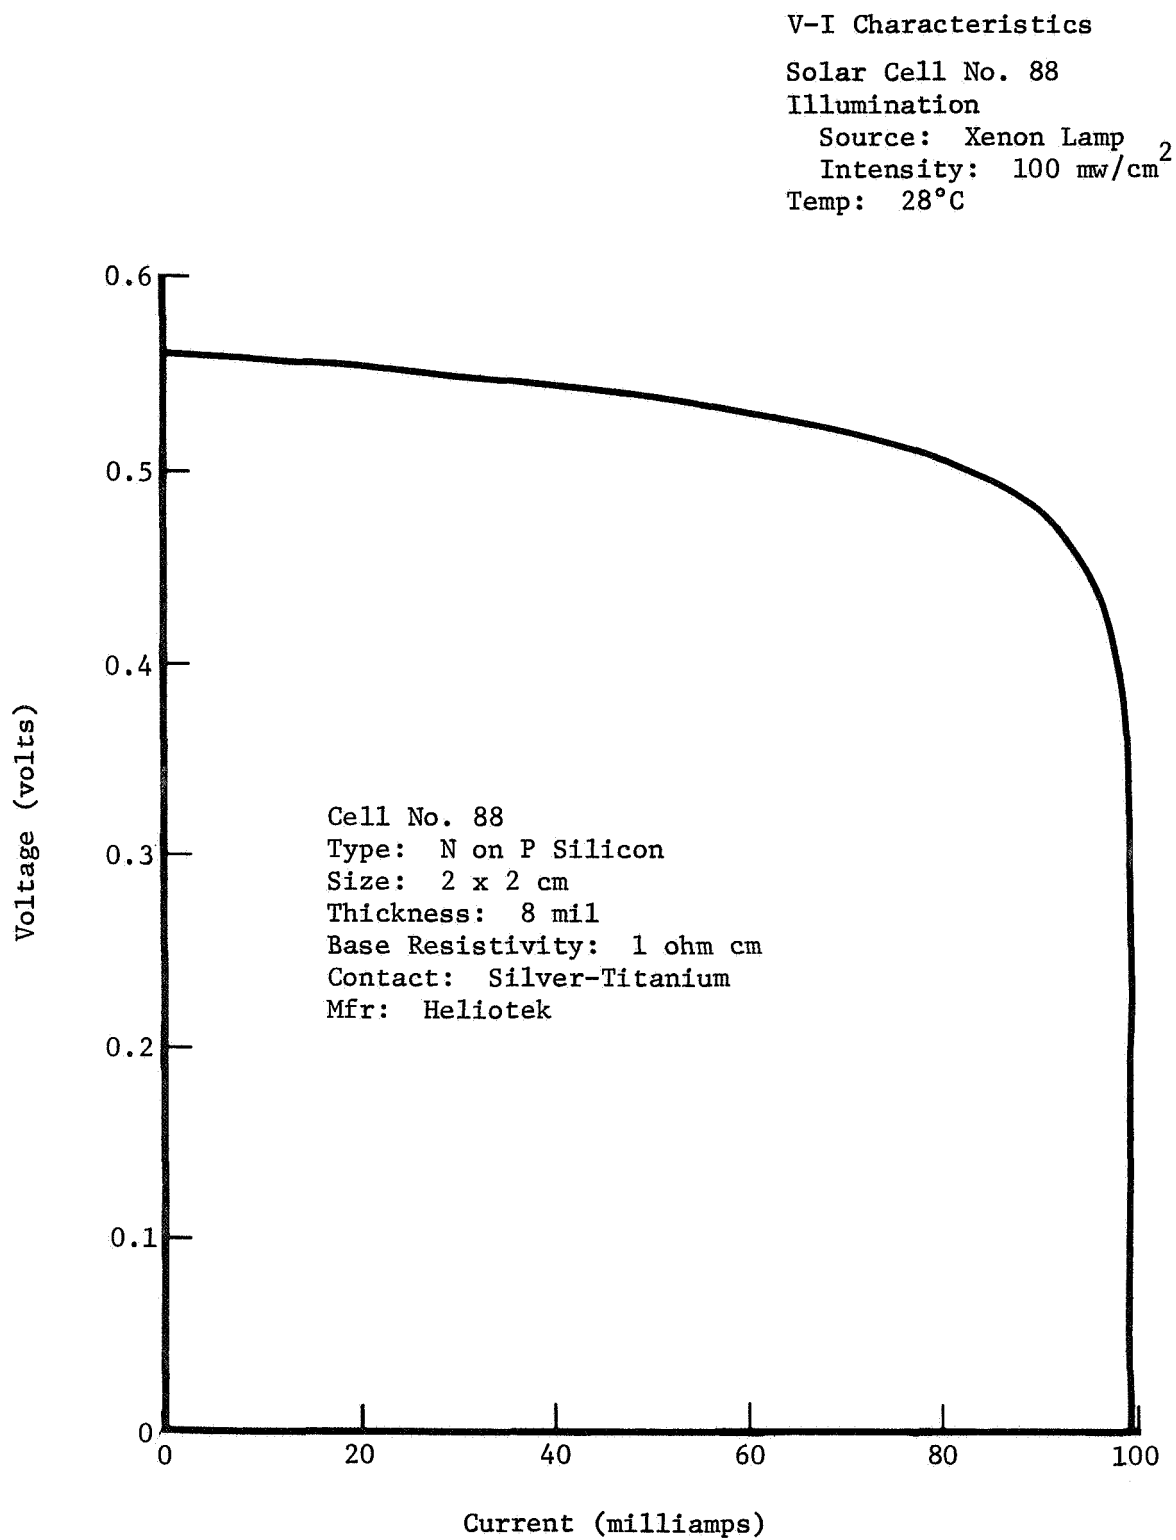
Figure 7: TYPICAL UNDEGRADED PERFORMANCE OF A SOLAR CELL

A reference voltage-current (V-I) curve was recorded for each cell before any electrochemical tests were performed with the cell. Figure 7 shows a typical V-I curve for an undegraded solar cell taken while the cell was illuminated with simulated space sunlight from an Xenon lamp. The potentiostatic tests were continued and V-I curves were periodically obtained until degradation occurred. Solar cells in 1N HCl solutions at potentials of 0.0V and -0.3V with respect to a SCE reference electrode degraded in 51 hours and 84 hours respectively, indicating that environmental accelerates degradation. It is significant that applying a potential between the electrolyte and the silver-titanium contact of the solar cell produces degradation at room temperature. The V-I curves show how electrochemical conditions affect degradation. Figure 8 shows severe degradation occurring after 51 hours at a potential of 0.0 volts in one-normal HCl. Somewhat less degradation occurred when

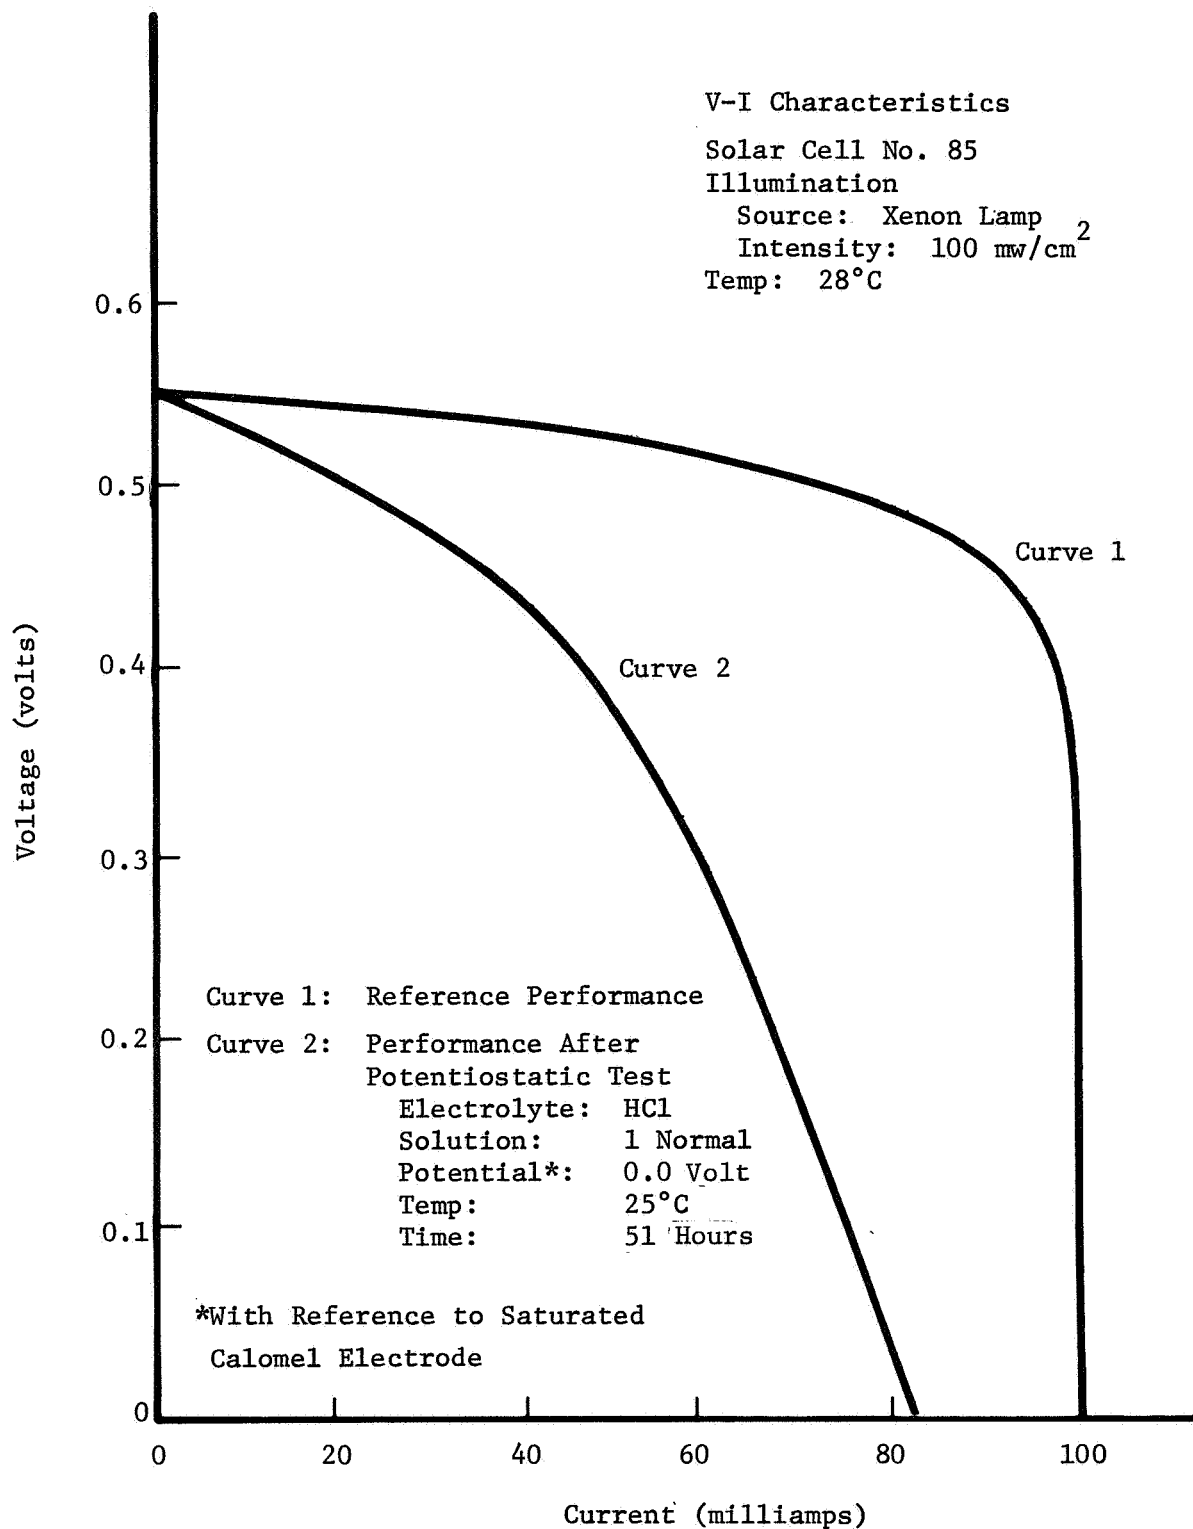
Figure 8: PERFORMANCE DEGRADATION FROM HCl AT 0.0 VOLTS

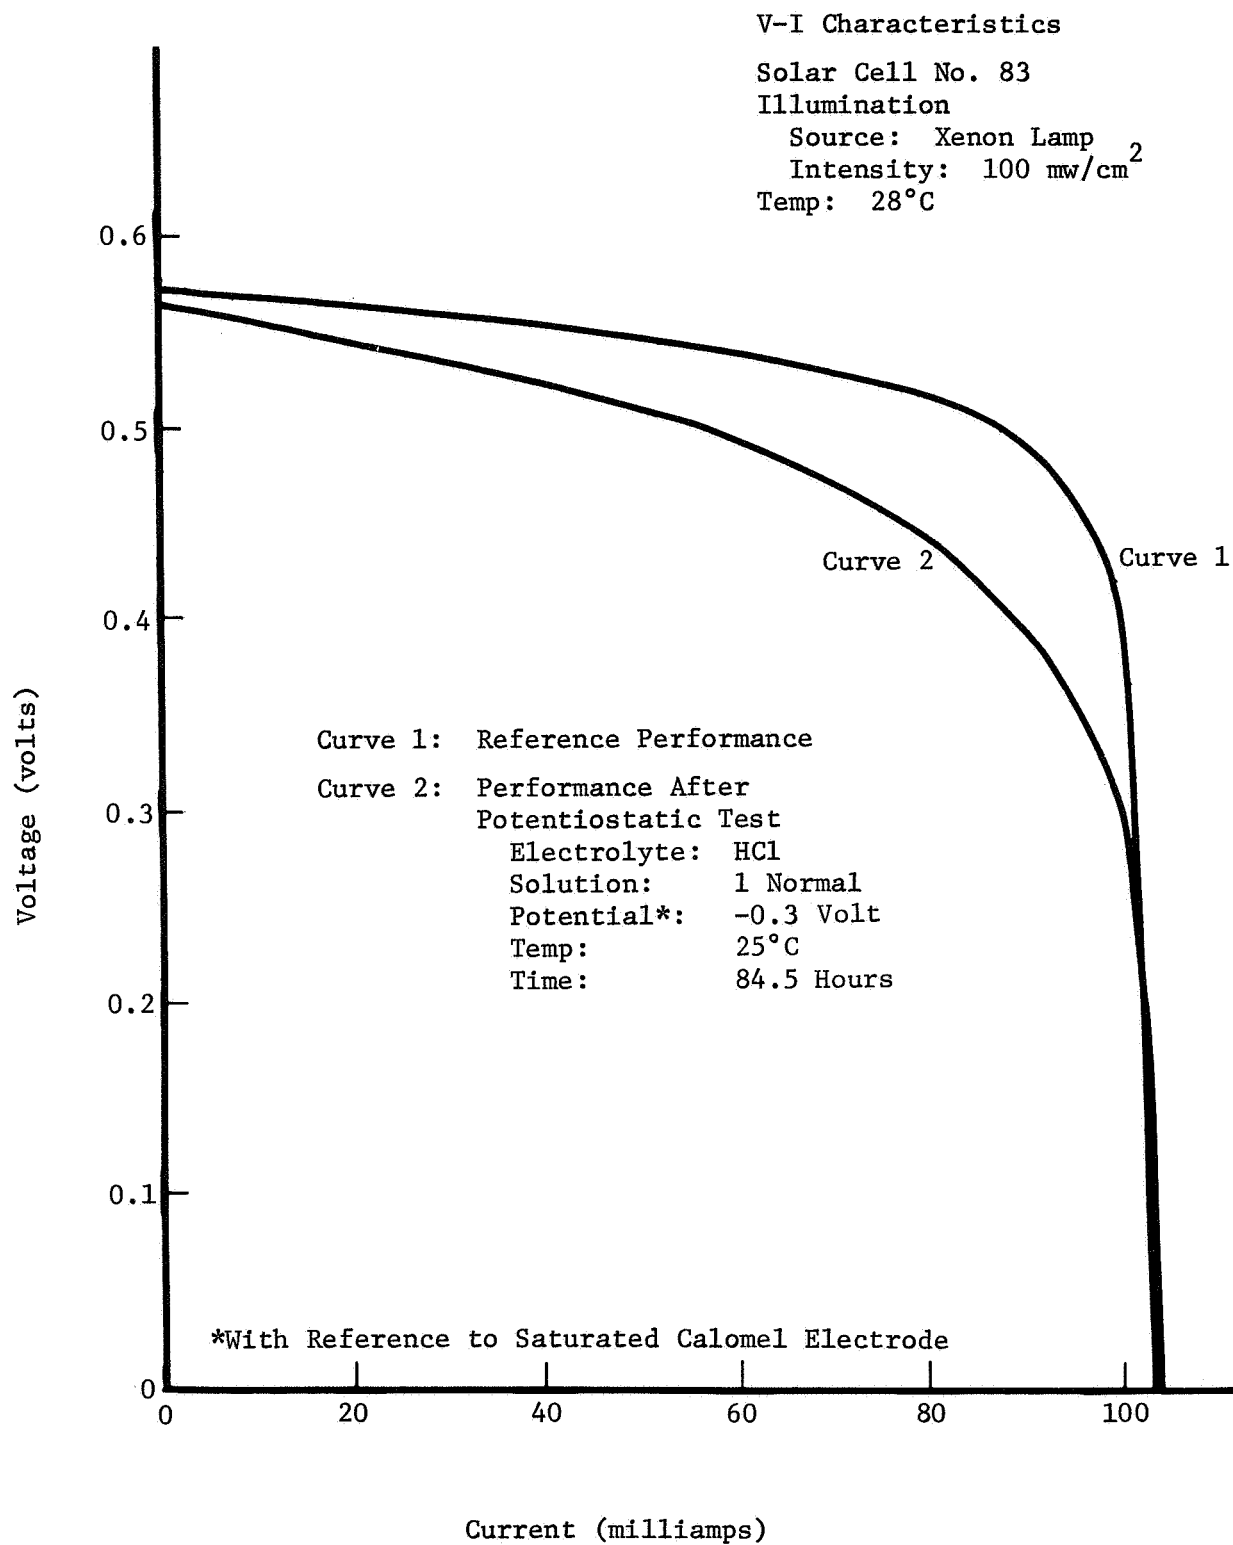
Figure 9: PERFORMANCE DEGRADATION FROM HCl AT -0.3 VOLTS

the potential was maintained at -0.3 volts (Figure 9). A photograph of the blistered cell is shown in Figure 10. Cell power as a function of time was determined from the V-I curves (Figure 11). The steady decrease in power indicates that degradation is a continuing process.

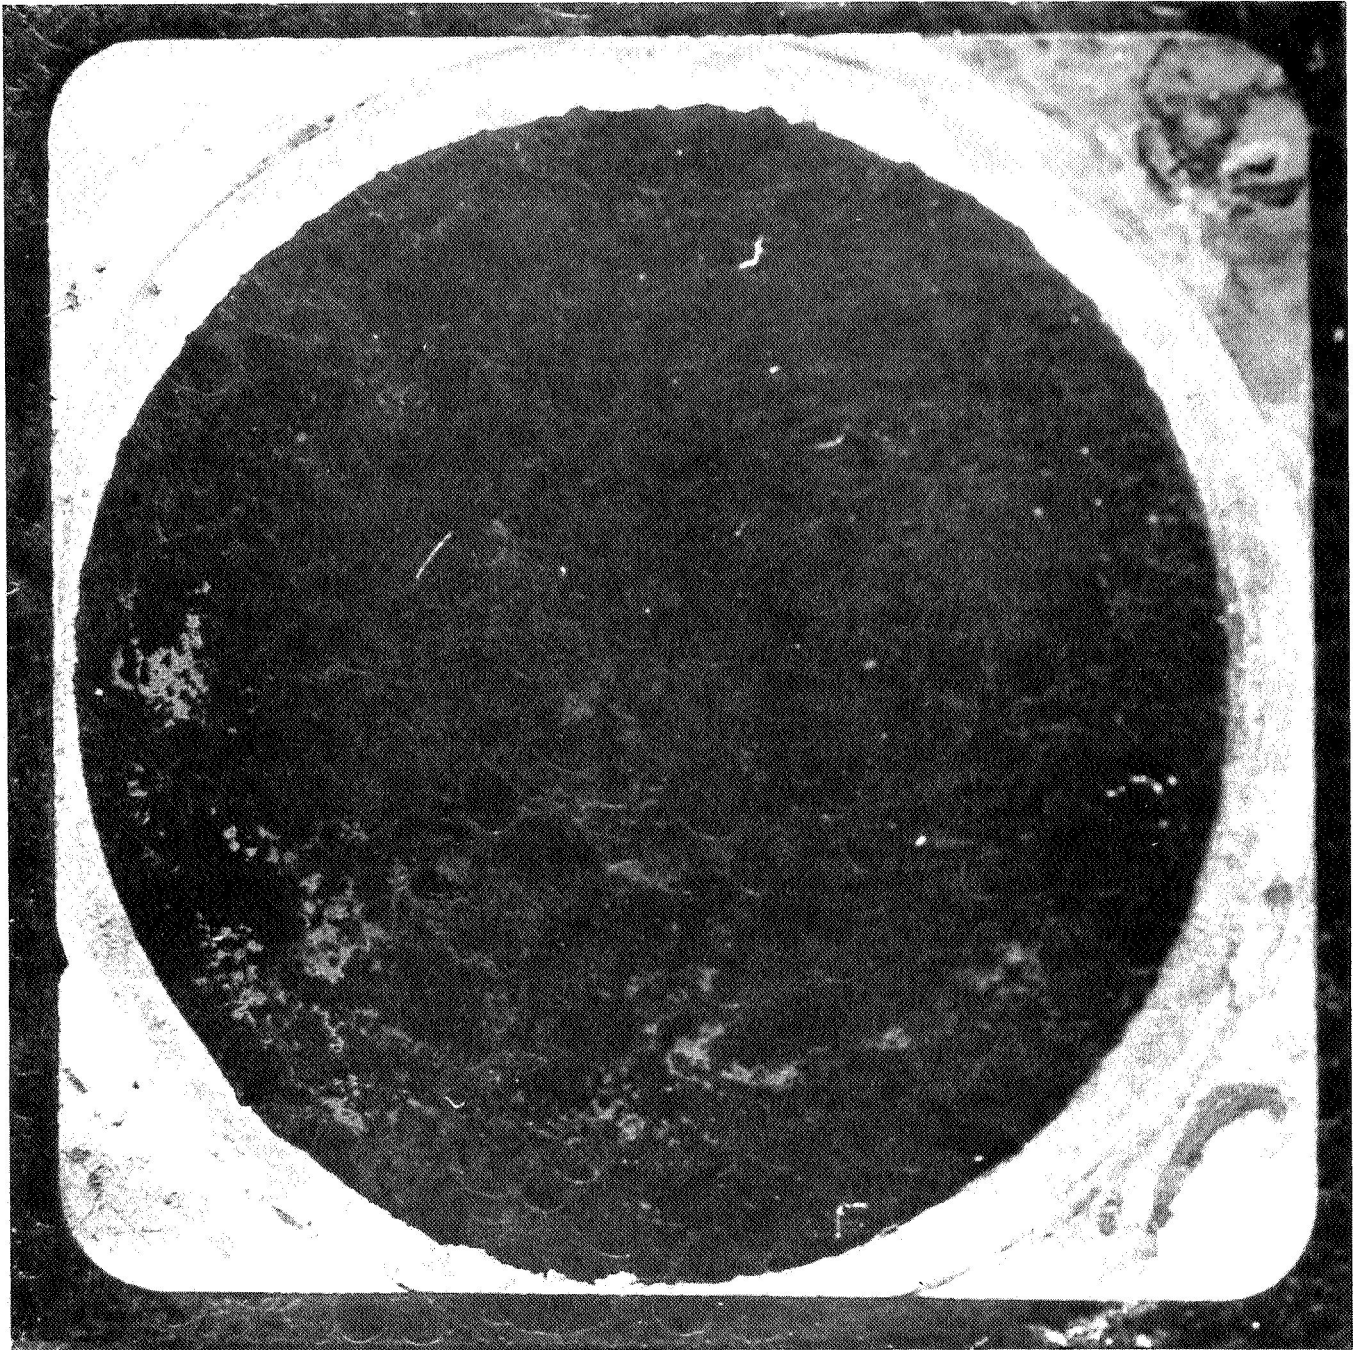
Figure 10: SOLAR CELL AFTER 84 HOURS IN HCl AT -0.3 VOLTS

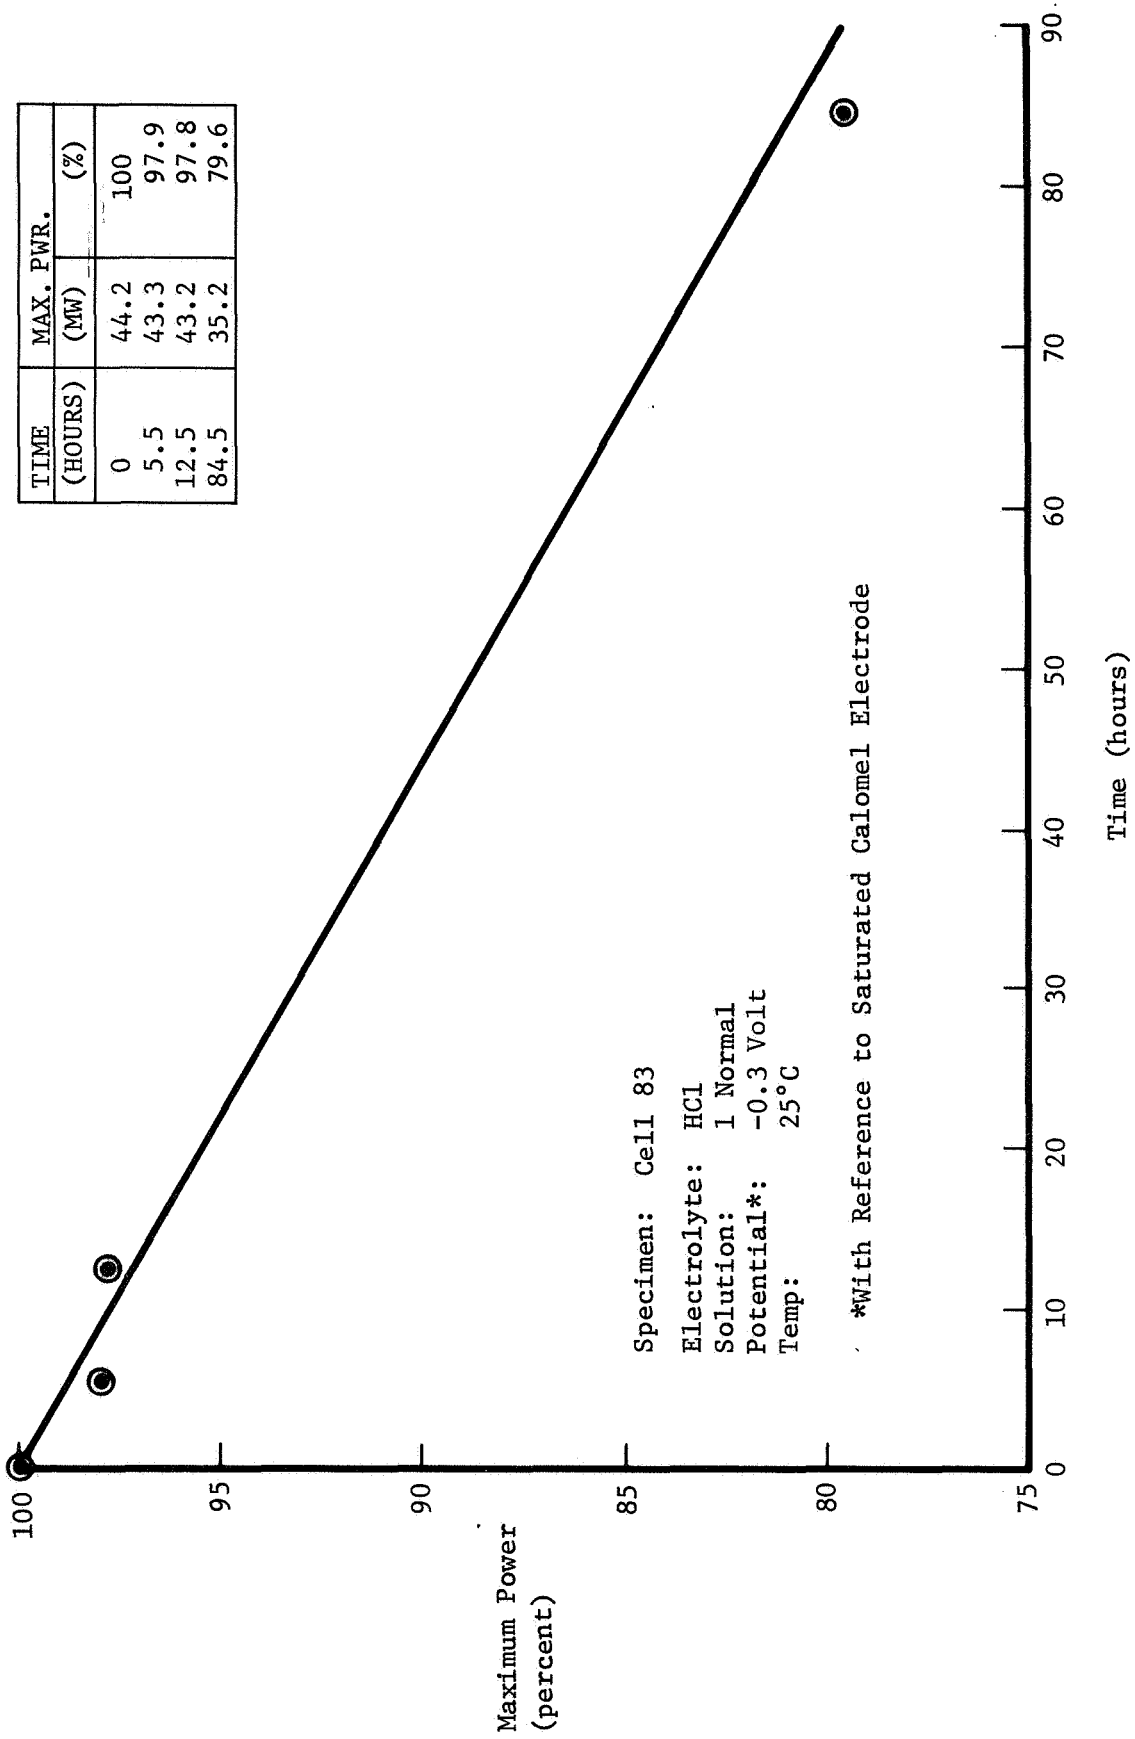
Figure 11: PERFORMANCE DEGRADATION RATE FROM HCl AT 0.0 VOLTS

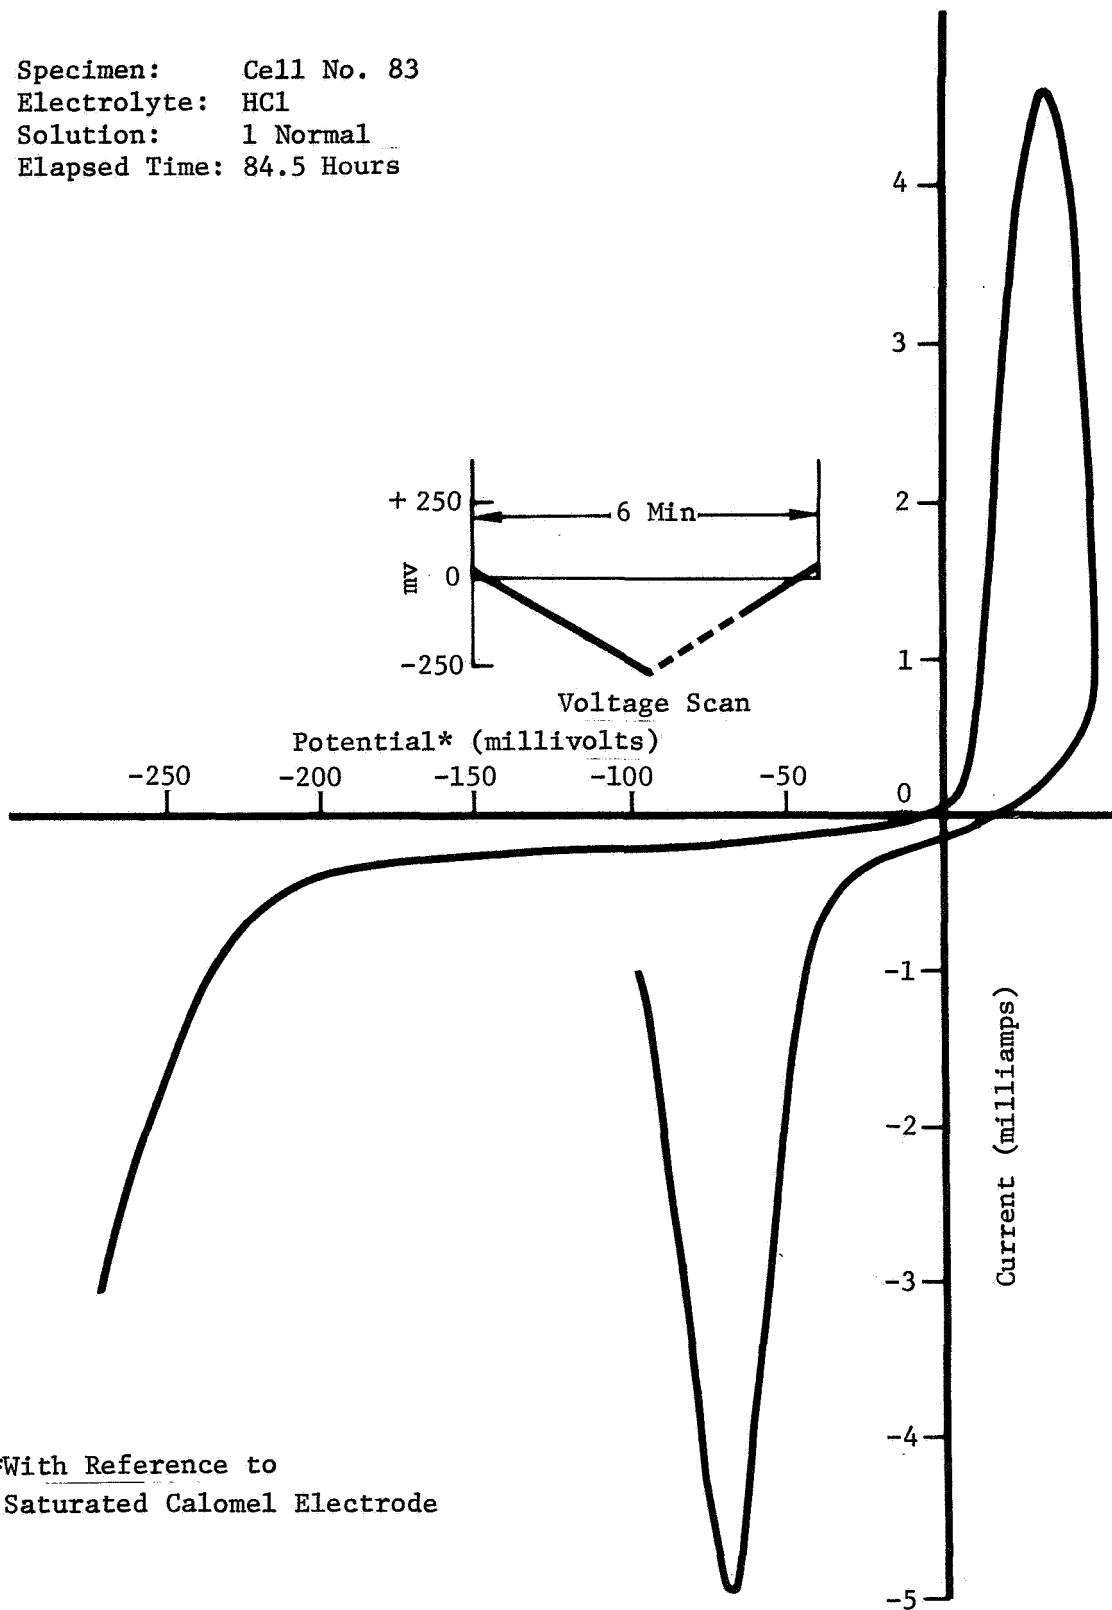
Specimen: Cell No. 83
Electrolyte: HCl
Solution: 1 Normal
Elapsed Time: 84.5 Hours

*With Reference to
Saturated Calomel Electrode

Figure 12: HCl POLARIZATION CURVE AFTER 84 HOURS AT -0.3 VOLTS

The polarization curve of a degraded cell (Figure 12) has a shape similar to the curve obtained before degradation took place, but the potential at which the cell becomes cathodic has dropped from -0.4 volts to -0.25 volts. This implies a change in hydrogen overpotential.
